MODBAR TECHNICAL BULLETIN #25 AV Tap handle assembly

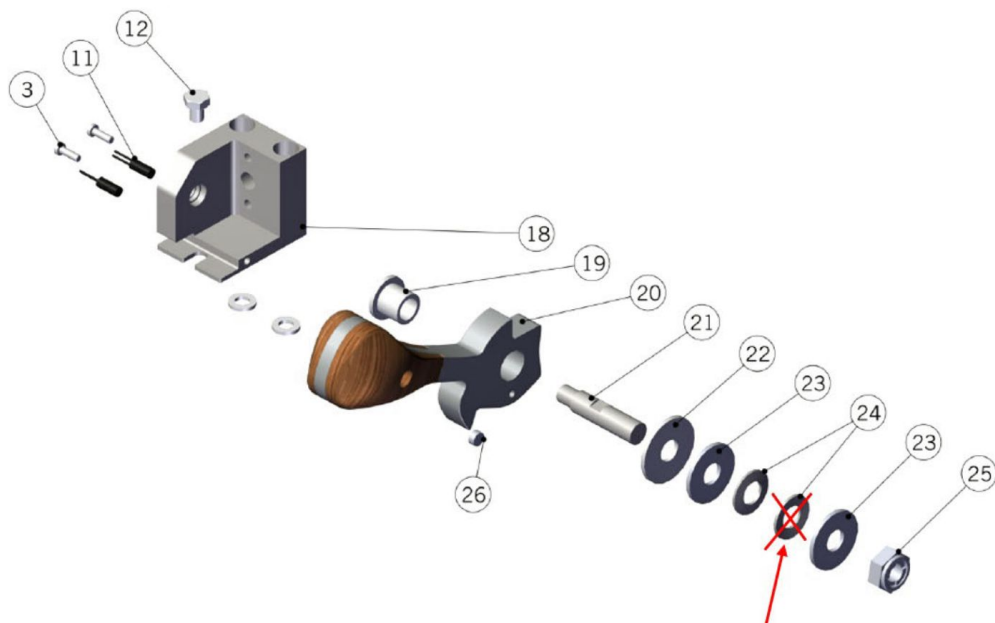
We would like to inform you of a modification that has been made to the AV tap handle assembly. In order to have a firmer fastening of the locknut, one of the two belleville washers has been removed from the assembly.

In the previous configuration, the locking element of the nut was very close to the end of the bolt it was attached to, making it possible to loosen with use and consequently induce the reed switch not to work properly.

This change will take effect from serial number AV00003091 and we suggest to replicate this solution also on previously assembled AV taps.
