MODBAR TECHNICAL BULLETIN  
#25  
**AV Tap handle assembly**

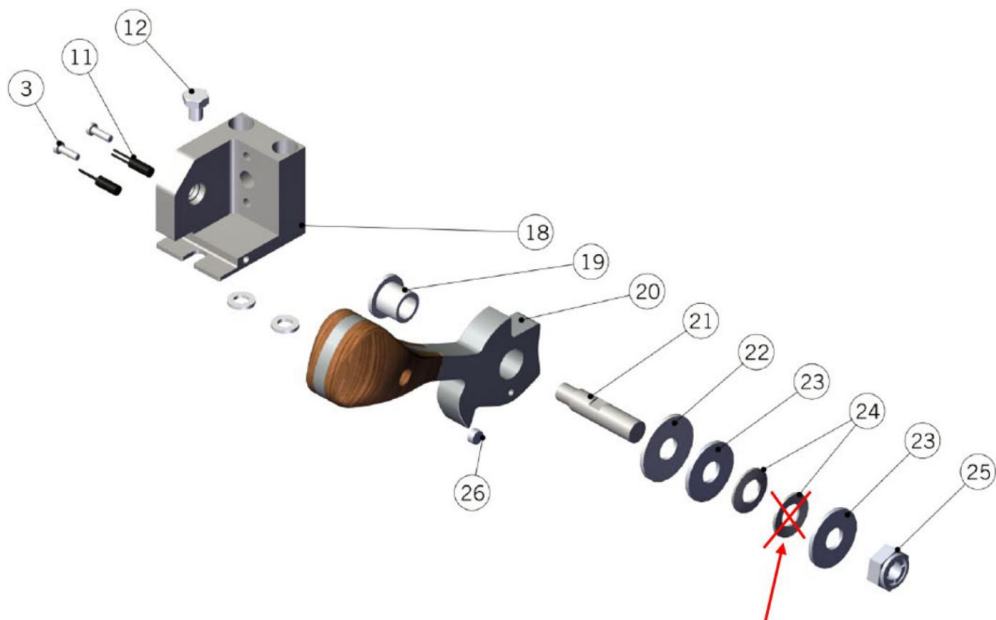
We would like to inform you of a modification that has been made to the AV tap handle assembly. In order to have a firmer fastening of the locknut, one of the two belleville washers has been removed from the assembly.

In the previous configuration, the locking element of the nut was very close to the end of the bolt it was attached to, making it possible to loosen with use and consequently induce the reed switch not to work properly.

This change will take effect from serial number MB001579 and we suggest to replicate this solution also on previously assembled AV taps.
